**Fire resistance test in  
accordance with BS. 476  
: Part 22 : 1987 on a  
Drywall Steel Sections  
Ltd. partition.**

Drywall Steel Sections Ltd.  
Rear of Masterfreight Ltd.  
A.M.K. House  
West Bromwich Street  
Oldbury  
West Midlands  
B69 3AY

Additional test report number  
244182

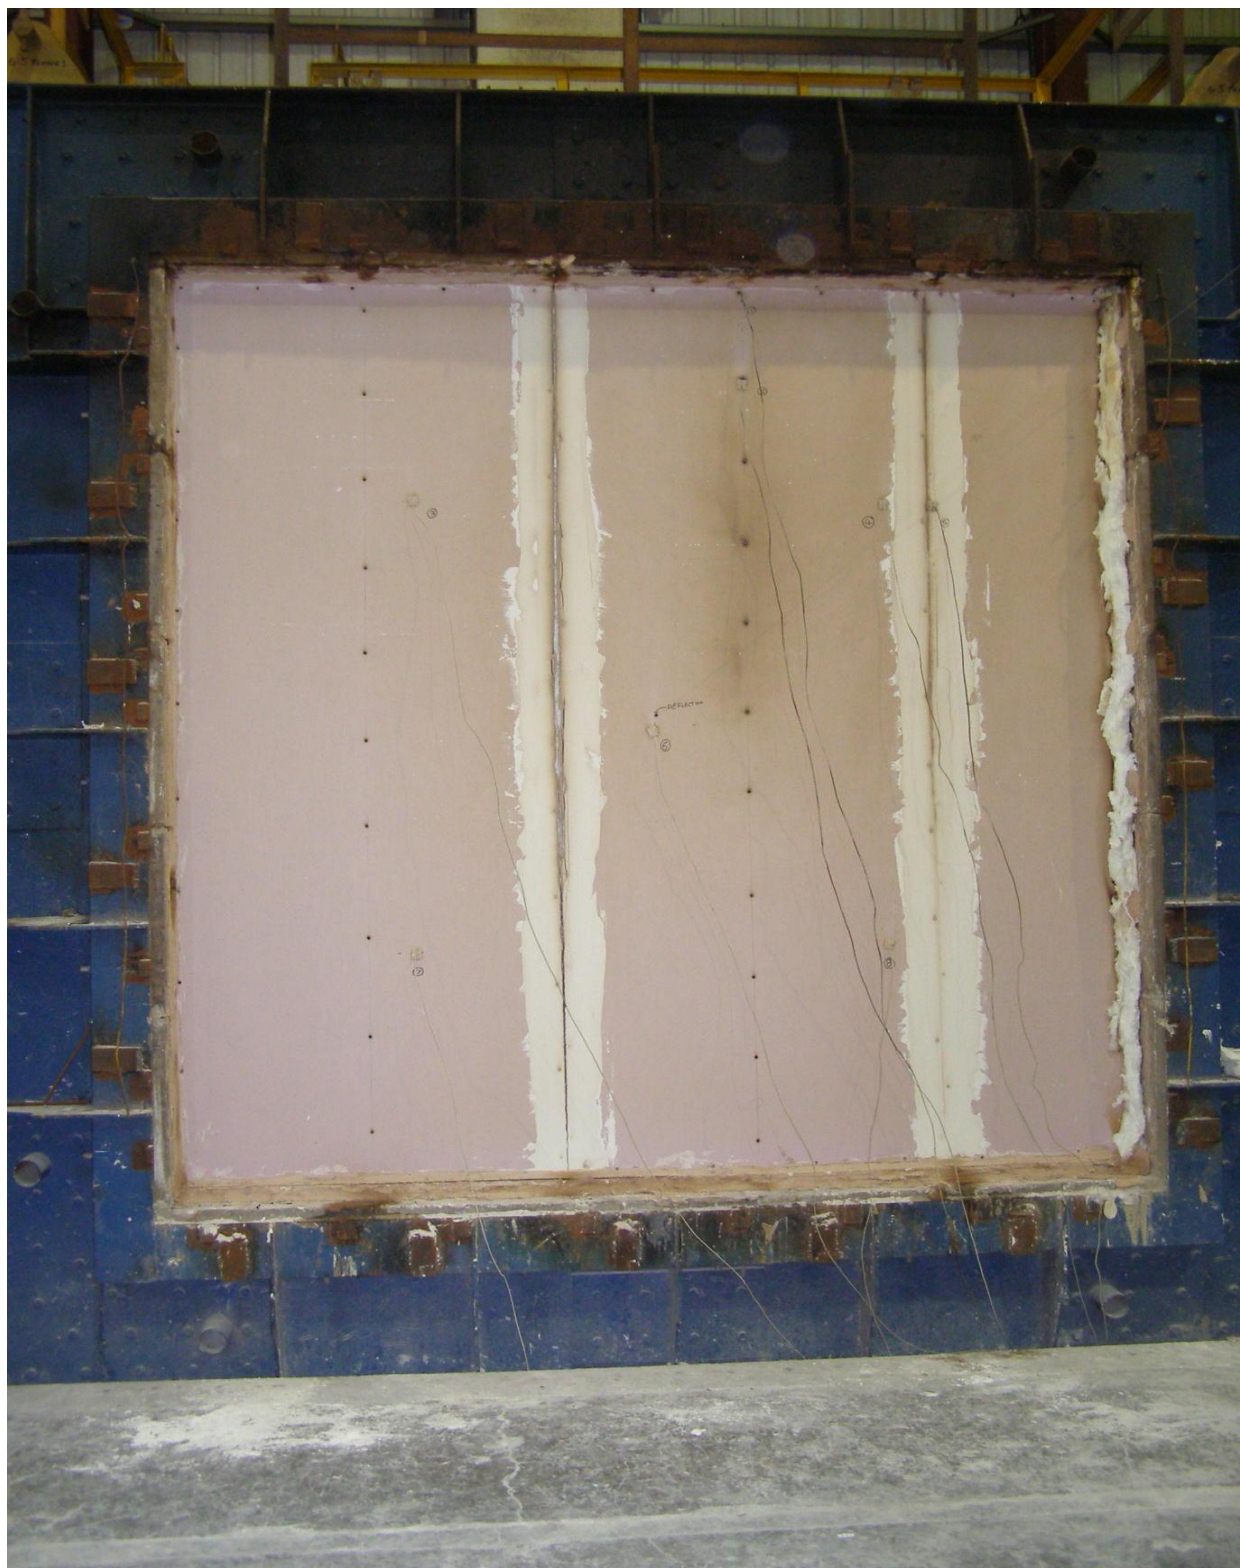
Time minutes	Observation
59	All boards are intact on the exposed face.
62	The crack referred to at 58 minutes is now approximately 1mm wide, and is darkening at its edges. There is no visible glow from this crack.
63	All boards are intact on the exposed face.
71	The crack referred to at 58 minutes is now approximately 3mm wide.
84	The crack referred to at 58 minutes is now approximately 5mm wide. No glow is visible at the crack.
98	All boards on the exposed face are still intact. Gaps between sheets of wallboard on the exposed face are now up to a maximum of approximately 10mm.
108	All boards on the exposed face are still intact. Gaps between sheets of wallboard on the exposed face are now up to a maximum of approximately 15mm.
116	All boards on the exposed face are still intact. Gaps between sheets of wallboard on the exposed face are now up to a maximum of approximately 30mm. A stud is clearly visible near the centre of the partition on the exposed face at this crack. The unexposed face is darkening in colour as it heats up.

**Photo 3** Unexposed face after 120 minutes.

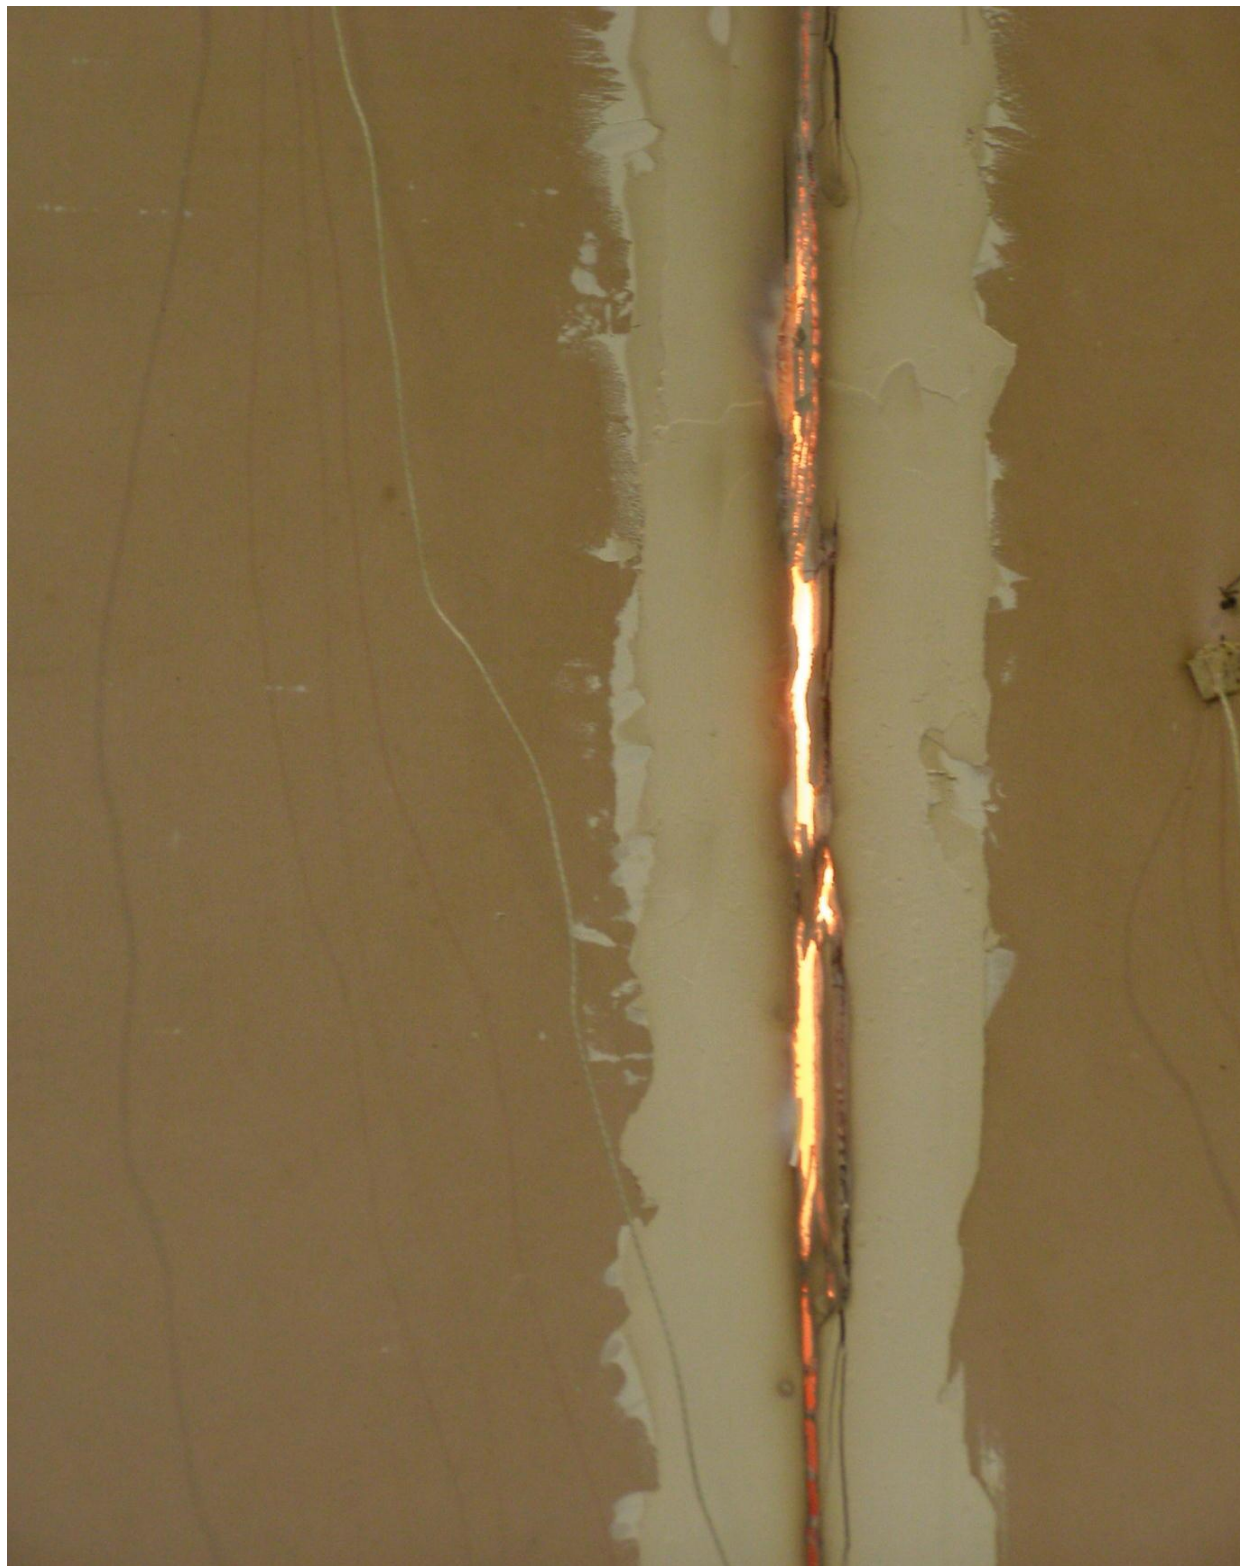
124	All boards on the exposed face are still intact.
126	A red glow is visible at the crack near the centre of the partition at mid height. No failure by cotton pad at this location.
128	A large piece of wallboard fell from near the centre of the exposed face.
129	Failure of integrity by cotton pad, flaming and 6mm gap gauge at the joint near the centre of the unexposed face.
130	Test stopped.

**Photo 4** Location of integrity failure (129 minutes).

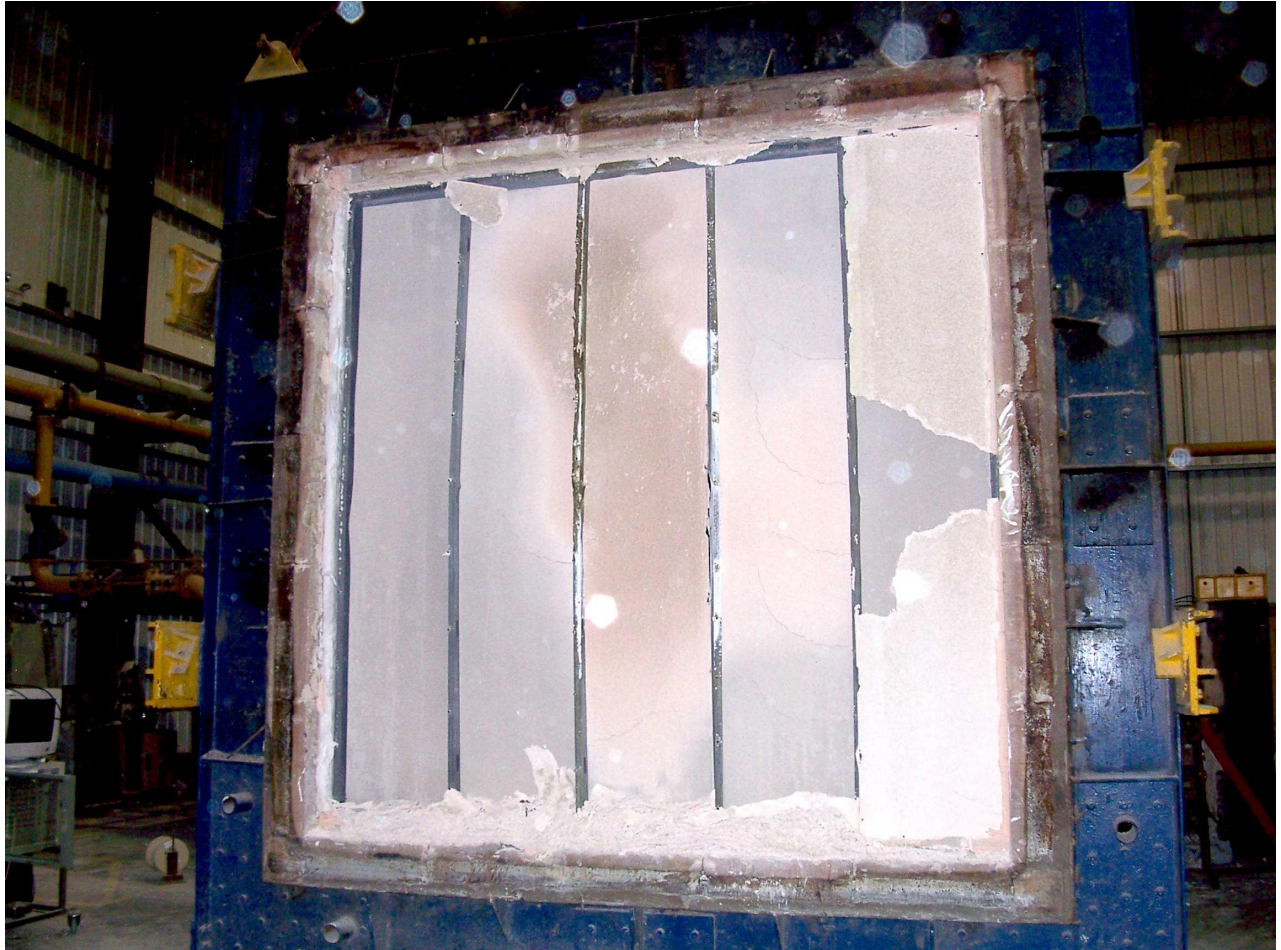
**Photo 5** Exposed face of specimen after test.
