**Fire resistance test in
accordance with BS. 476
: Part 22 : 1987 on a
Drywall Steel Sections
Ltd. partition.**

Drywall Steel Sections Ltd.
Rear of Masterfreight Ltd.
A.M.K. House
West Bromwich Street
Oldbury
West Midlands
B69 3AY

14th April 2008

Additional test report number
244182

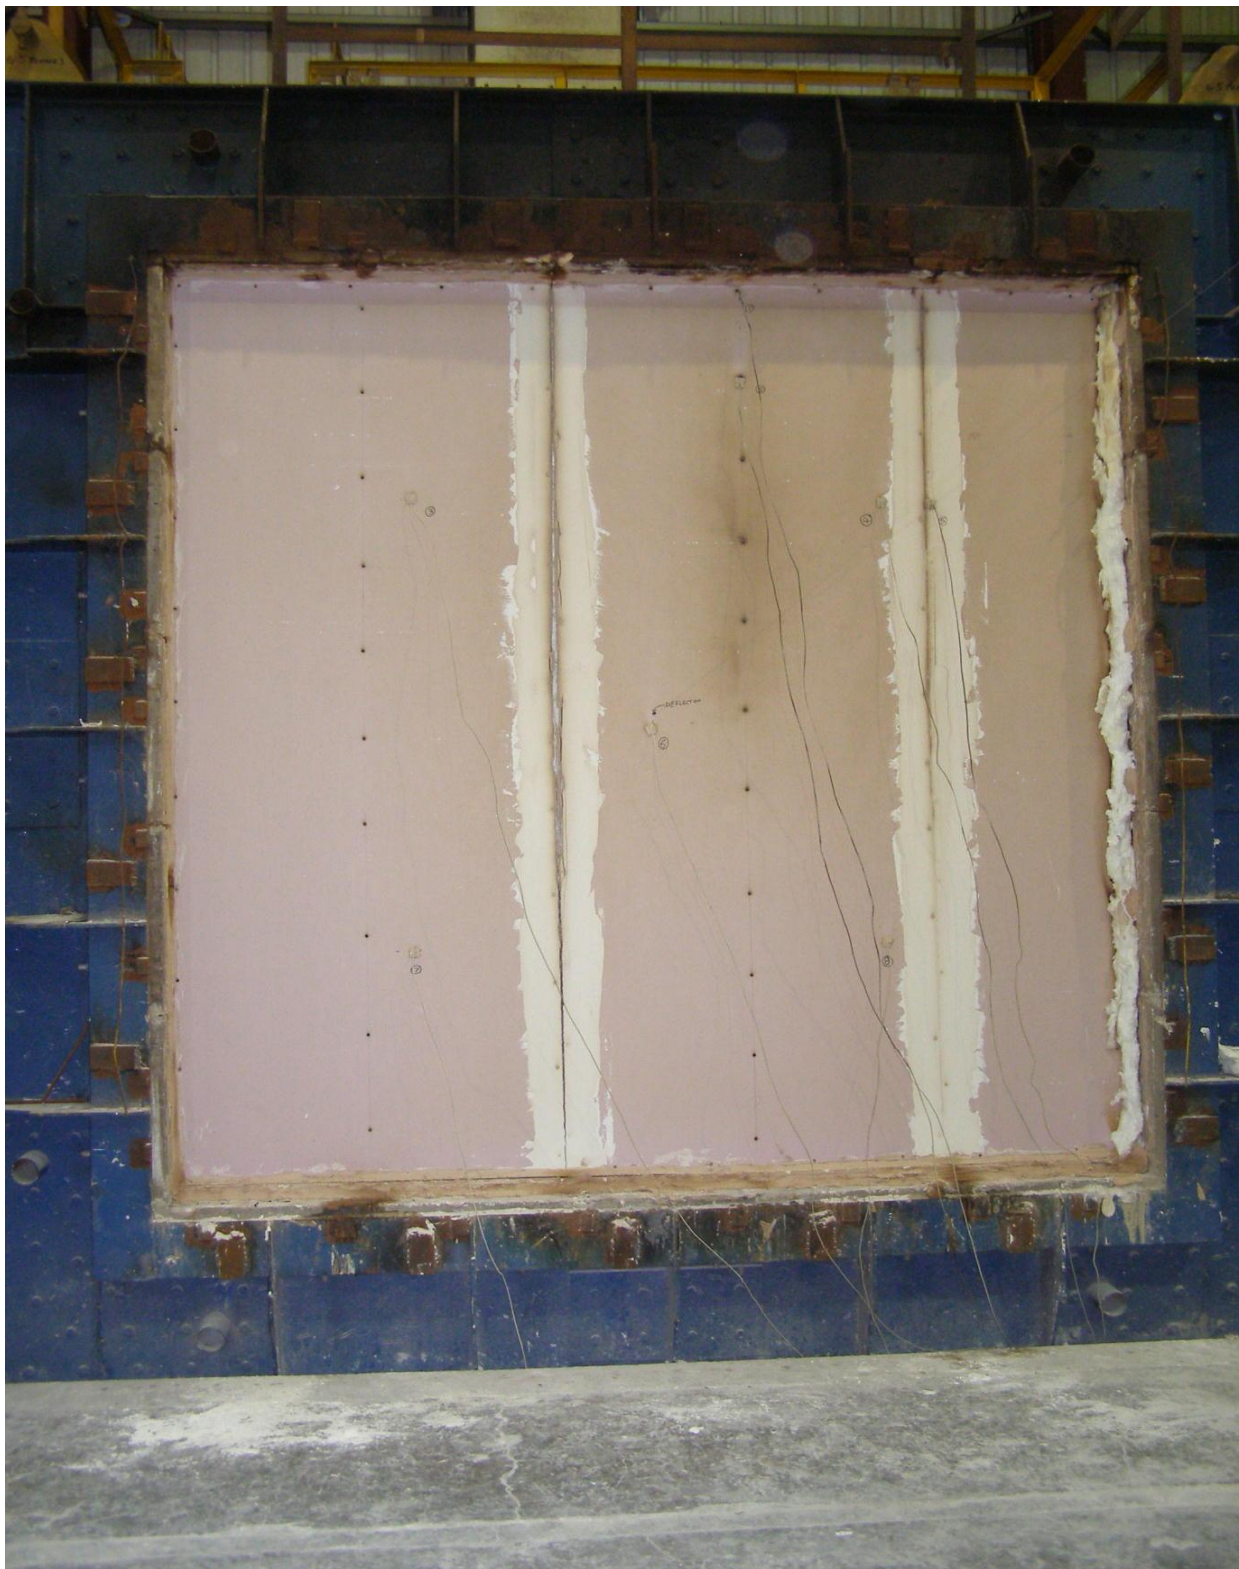
Photo 3 Unexposed face after 120 minutes.

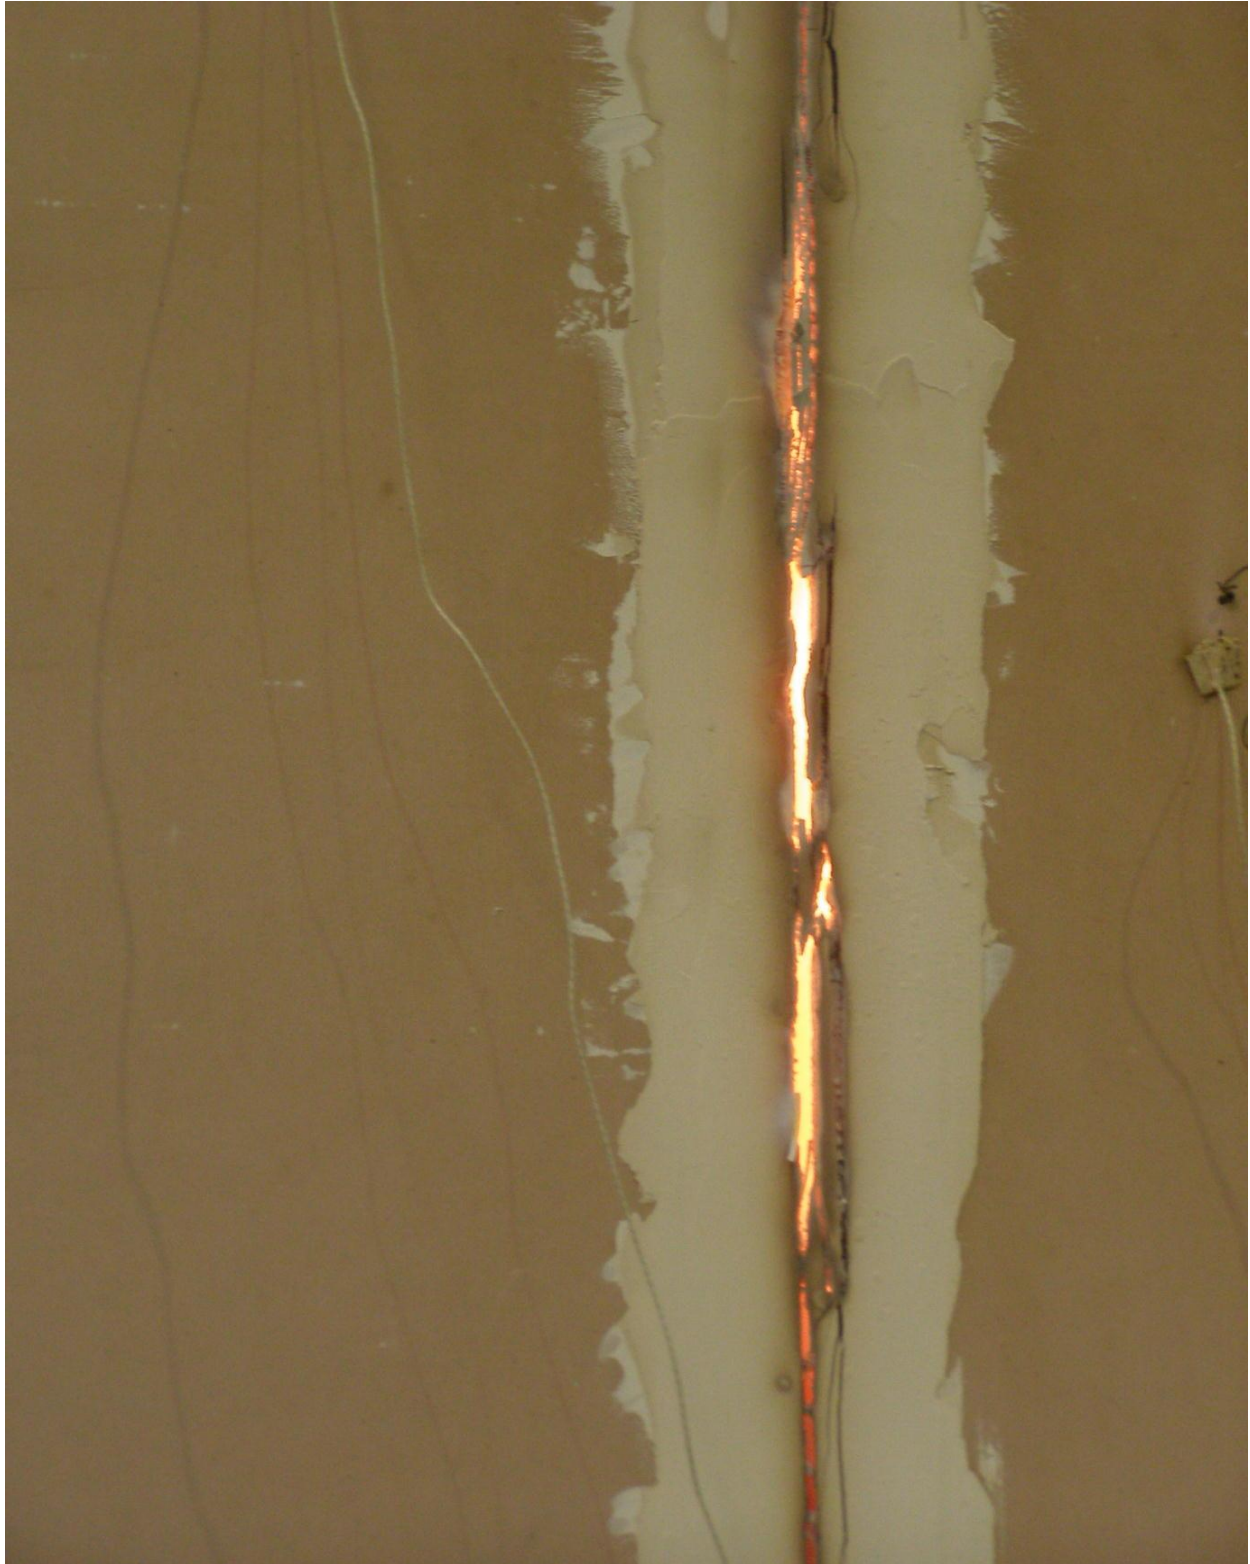
124	All boards on the exposed face are still intact.
126	A red glow is visible at the crack near the centre of the partition at mid height. No failure by cotton pad at this location.
128	A large piece of wallboard fell from near the centre of the exposed face.
129	Failure of integrity by cotton pad, flaming and 6mm gap gauge at the joint near the centre of the unexposed face.
130	Test stopped.

Photo 4 Location of integrity failure (129 minutes).

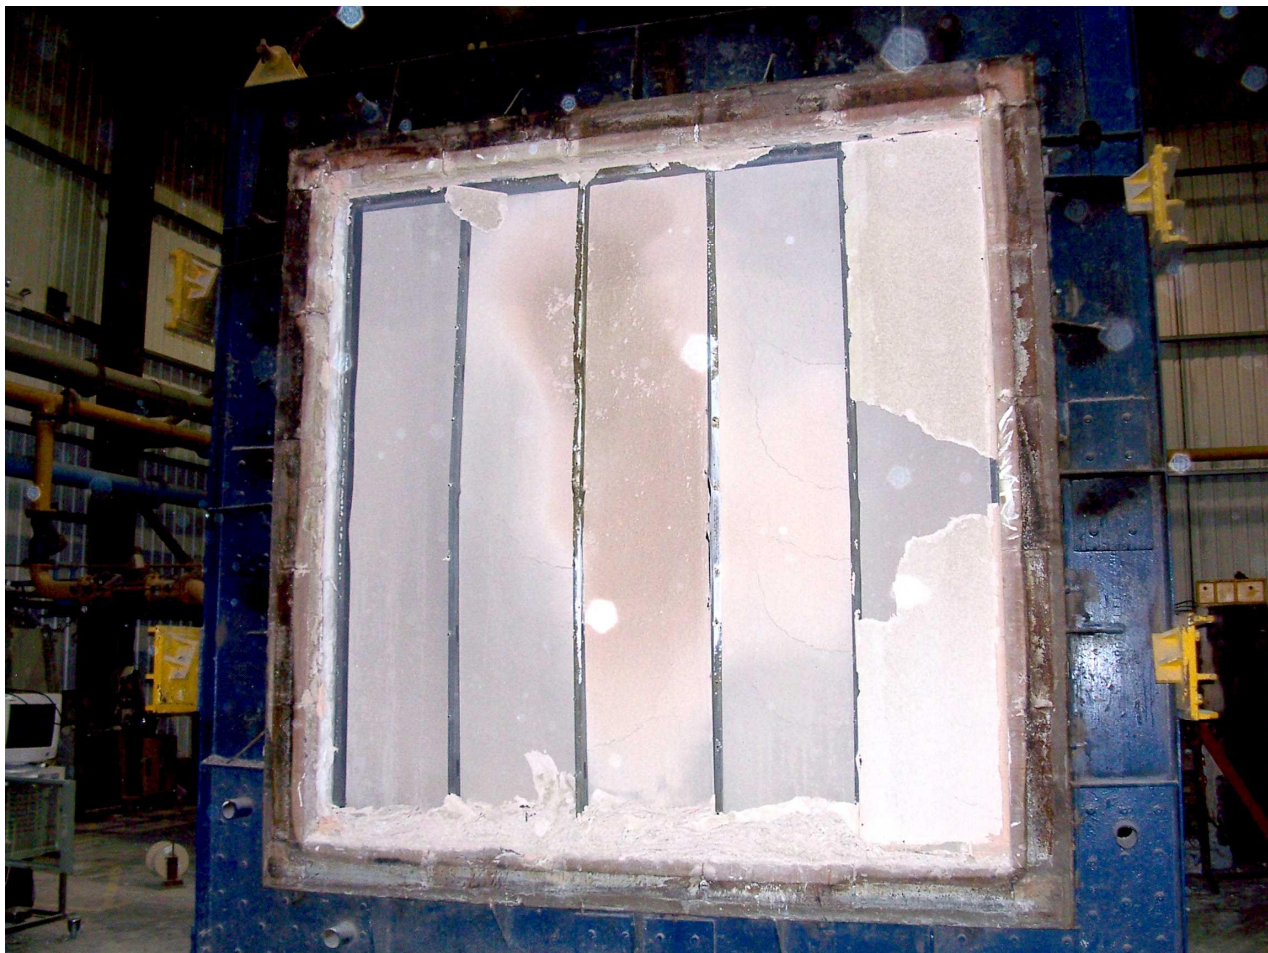
Photo 5 Exposed face of specimen after test.
