**Fire resistance test in  
accordance with BS. 476  
: Part 22 : 1987 on a  
Drywall Steel Sections  
Ltd. partition.**

Drywall Steel Sections Ltd.  
Rear of Masterfreight Ltd.  
A.M.K. House  
West Bromwich Street  
Oldbury  
West Midlands  
B69 3AY

Additional test report number  
244182

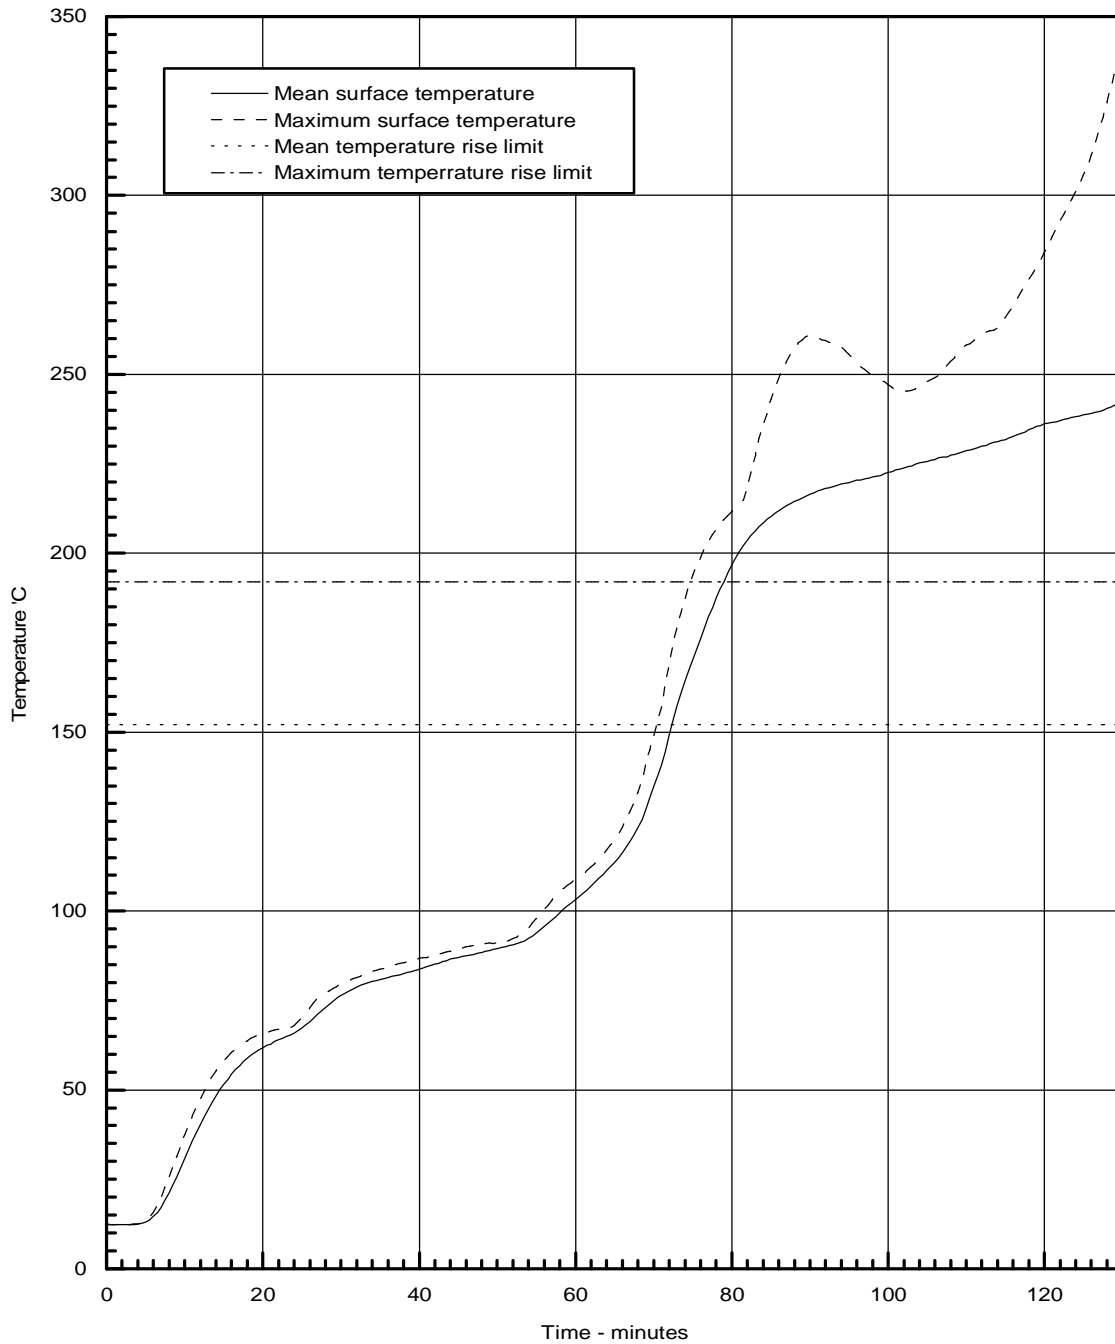
**Graph 2** Mean and maximum temperatures recorded on the unexposed face of the specimen.

Integrity:	129 minutes
Insulation:	72 minutes
